TECHNICAL BULLETIN

SIDE-LOAD COIL SPRINGS Correct Fitment

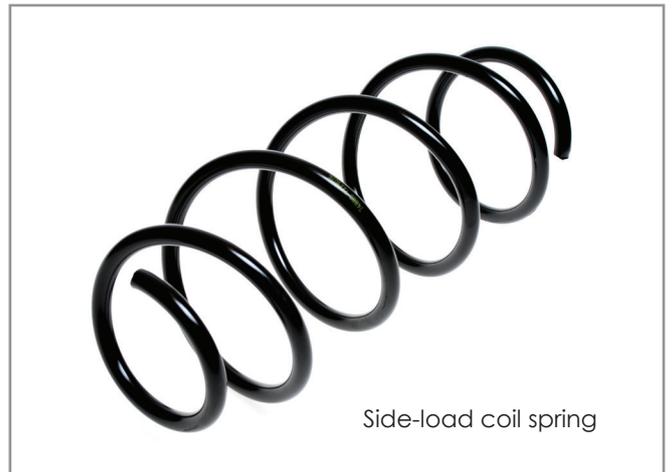
The first image shows a correctly fitted spring, with the top spring plate in the correct position. The spring straightens once force is applied.

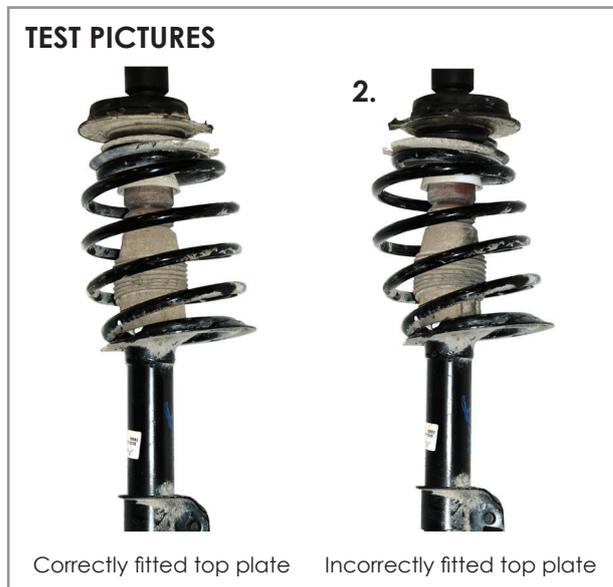
However if the top plate is positioned incorrectly the spring will bend, which can result in it touching the inner wing and creating noise.

The second image shows the top plate twisted out of position by 180 degrees. The spring has not straightened, and may touch the inner wing, creating noise.

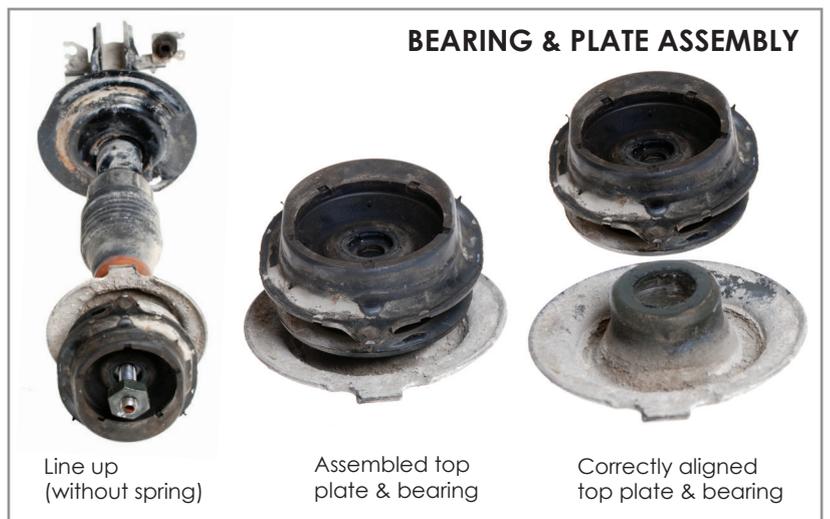
It should also be noted that the top plate and bearing are separate parts which can easily be taken apart and put together (if accidentally dropped they will normally split into two pieces), and that it is possible to rotate the top bearing into any position and still fit it to the top plate.

It is therefore important to check that the plate and bearing are lined up correctly.

To do this the rubber tag on the top bearing should line up with the slot in the top plate, which in turn should line up with the bottom end fitting of the assembled strut.
